PROPERTY CONDITION ASSESSMENT
OF
WORLD TRADE CENTER PORTFOLIO

FOUR WORLD TRADE CENTER

Property #4
Merritt & Harris, Inc. Project Number 20-251E

December 6, 2000

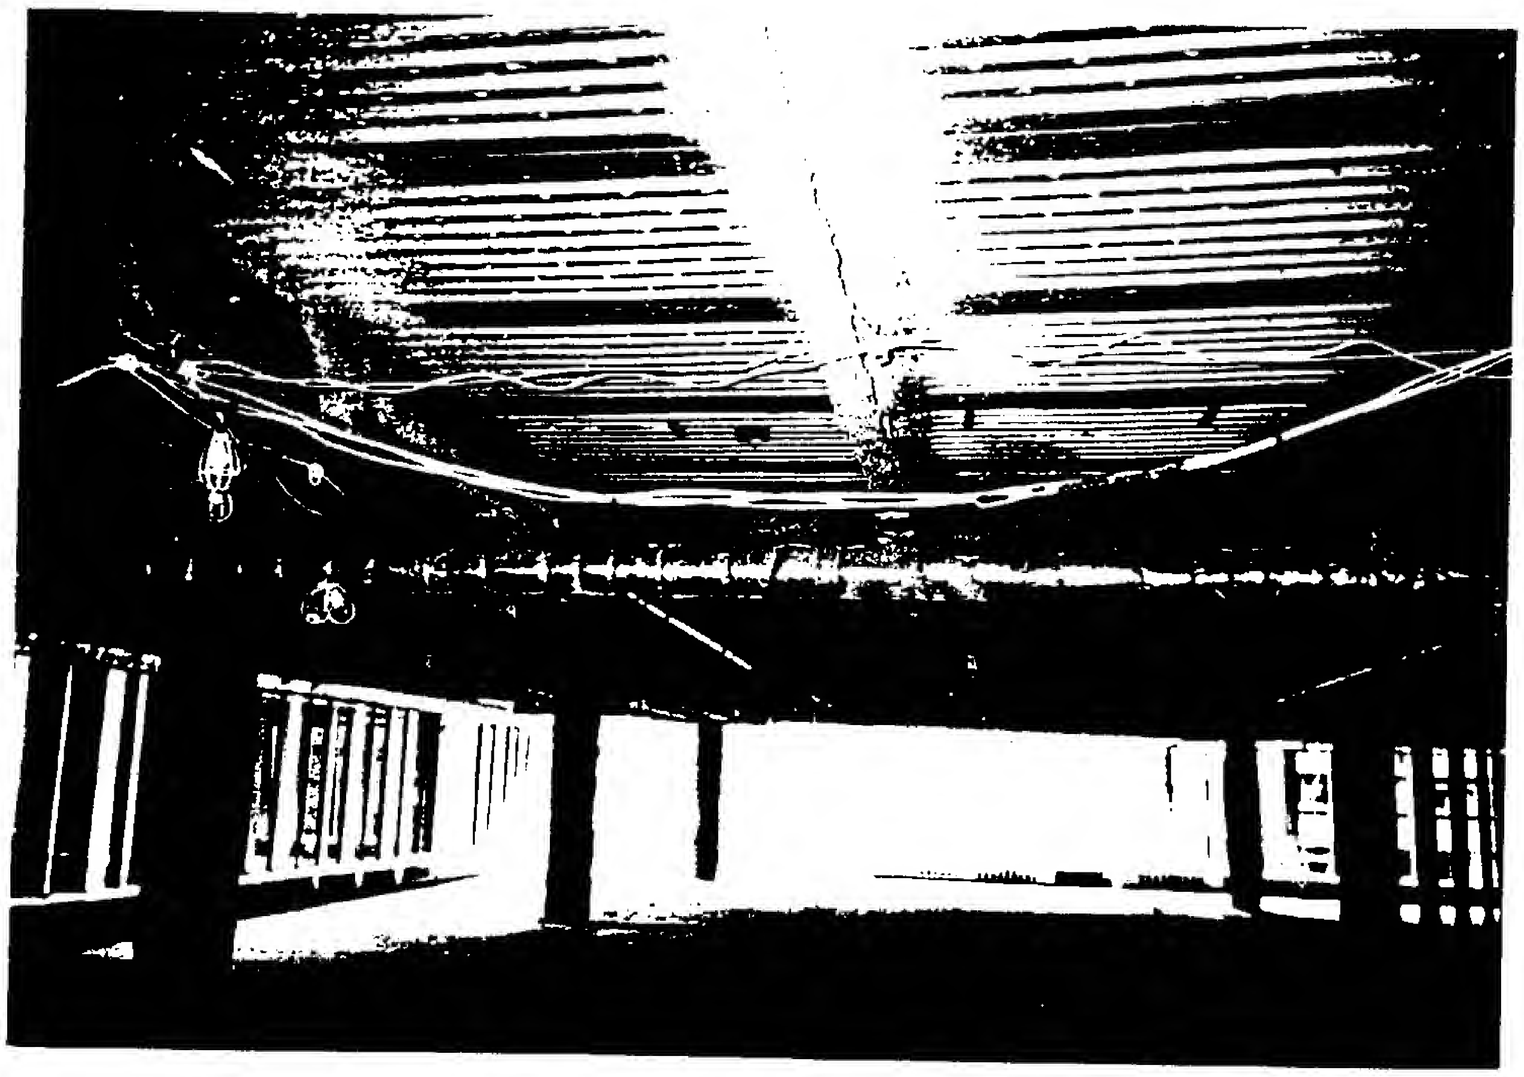
Photograph 3

Existing structure below building at B-2 level remaining from PATH station

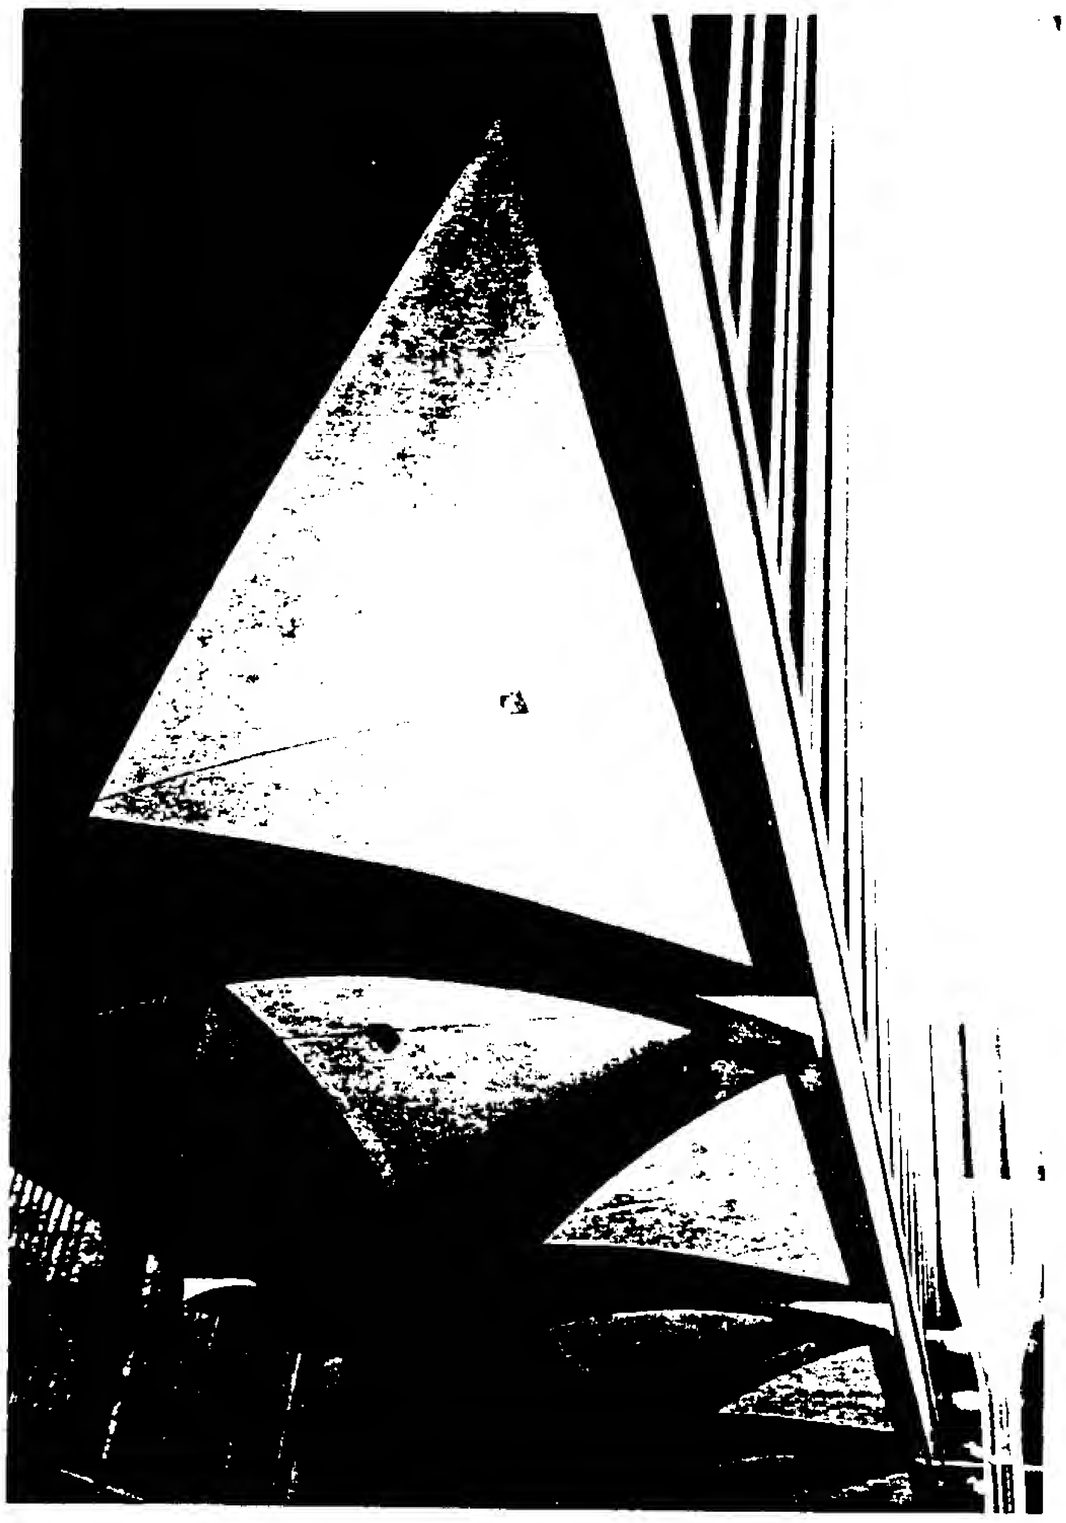
Photograph 6

Framing of cantilever below 4th floor deck

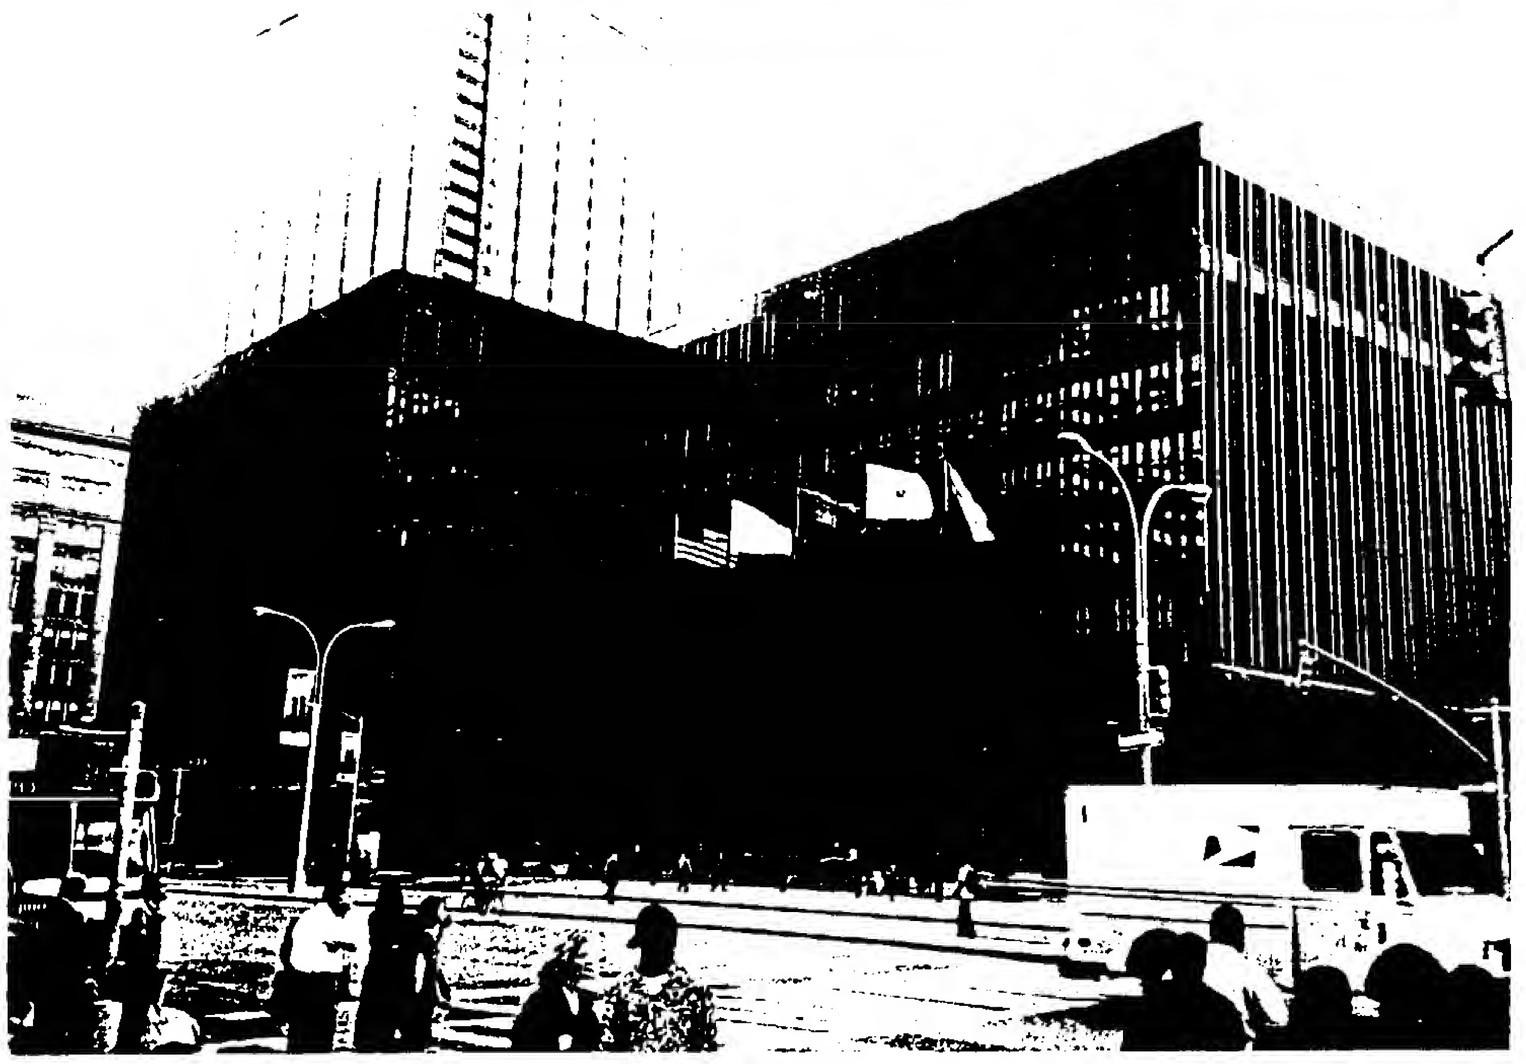
Photograph 7

Aluminum cladding conceals steel truss to support cantilever at 4th floor overhang

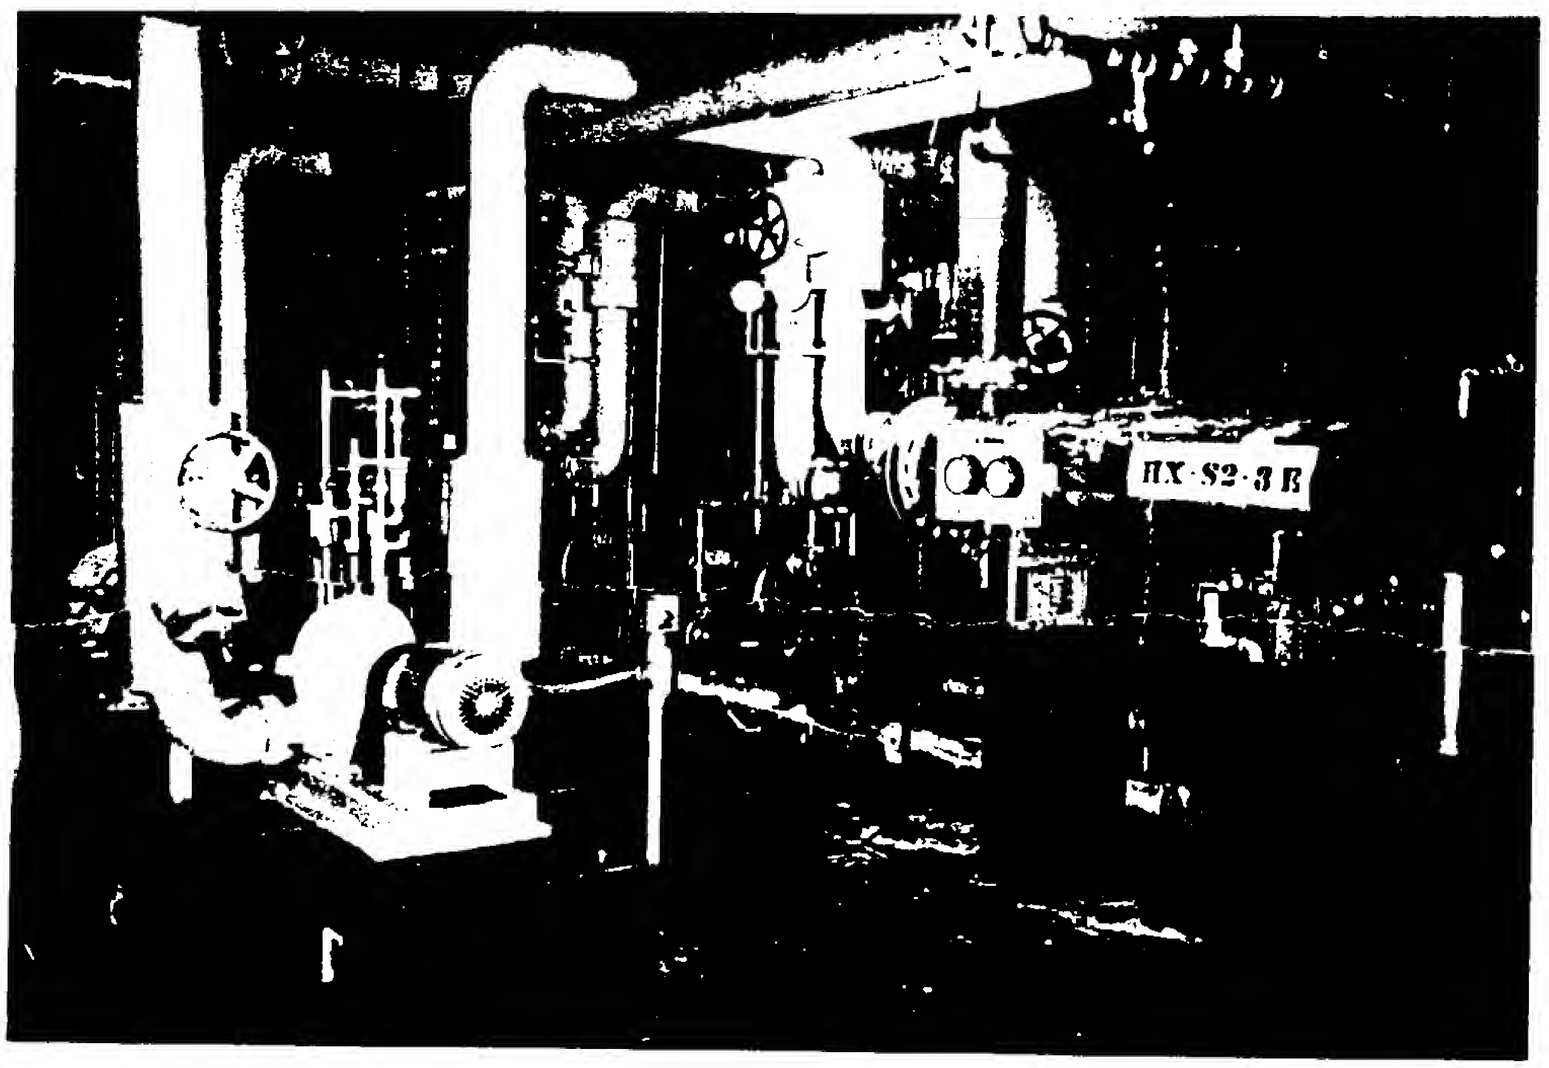
Photograph M5

Condenser water supply and return lines for tenant supplementary air conditioning

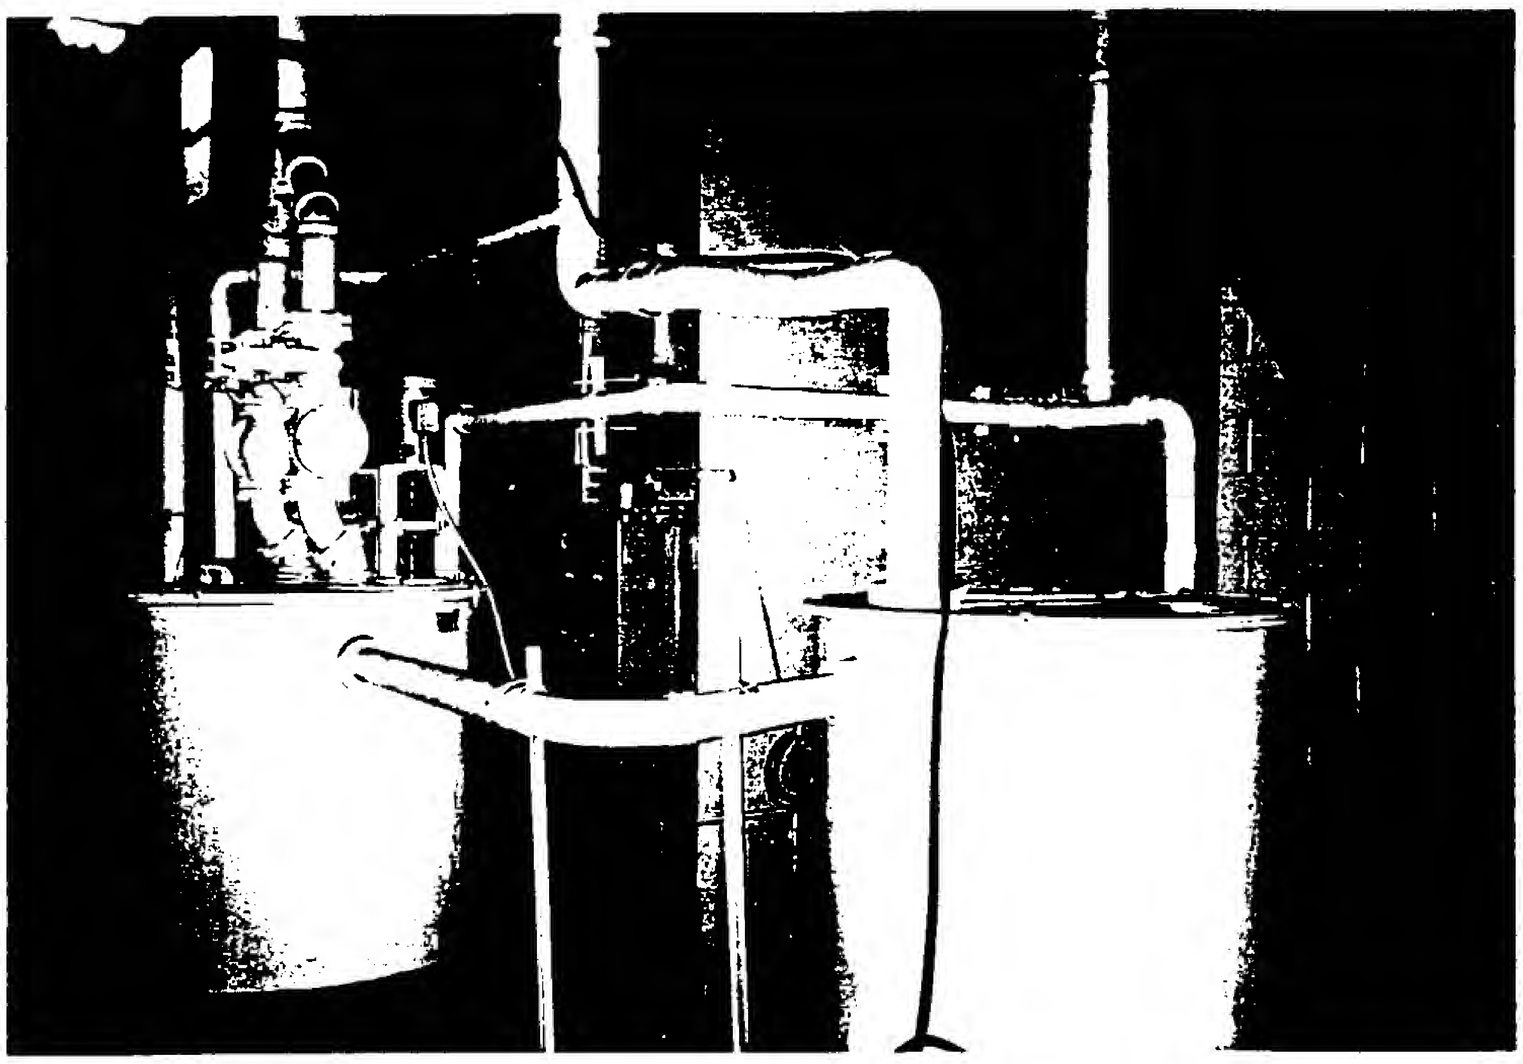
Photograph M6

Heat exchanger and circulating pump for heating hot water
